**An Excerpt From
A Report On The Operational Condition
And
Repair vs. Replace Recommendation
of
Pump No. 2
By
Sydnor Hydro, Inc.**

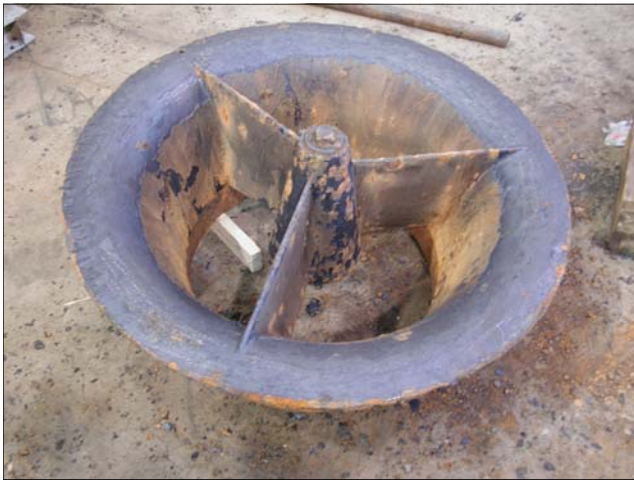
Suction Bell & Lower Bearing Assembly

The pump body, suction bell, column and discharge elbow were found to be sound and free of any significant corrosion. It is our recommendation that these components be recoated and returned to service. This is also true of the base plate and motor pedestal assembly. No deterioration was noted when these components were inspected.

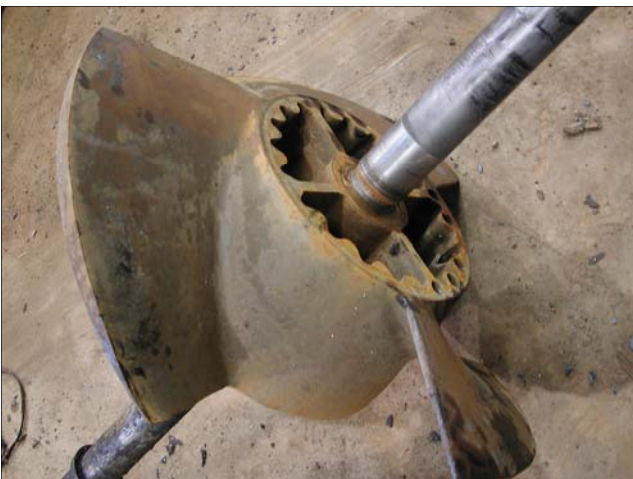
Propeller

The pump propeller and sand collar assembly is in remarkably good condition. There is no evidence of erosion, damage or distortion. The pump bowl shaft is in good condition and can be returned to service with no restorative work required. The line shaft should be replaced.

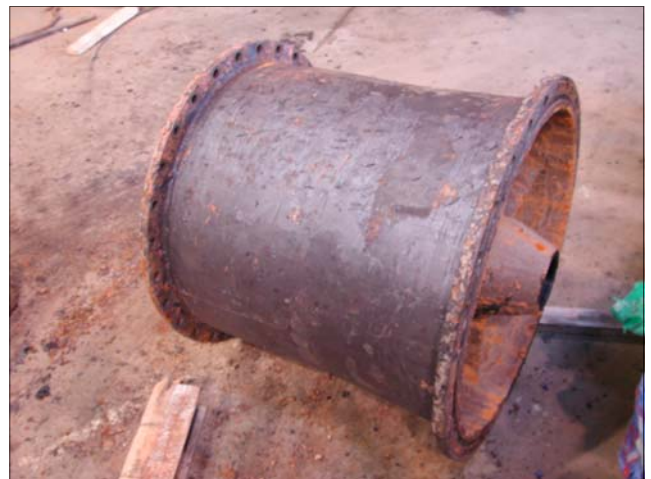
Top Bowl Assembly, Mechanically Cleaned

The pump bowl assembly is in good condition. The bowl bearing should be replaced.
